A Catastrophic Collapse: Windsor Building Fire (Madrid, 2005)

Montalva A. PE. Hinman Consulting Eng., San Francisco, CA, US
Pons i Frigola, V. Oficina Tecnica de Ingenieria Forense, Valencia, Spain
Herrera O. Oficina Tecnica de Ingenieria Forense, Valencia, Spain
Gilsanz, R. P.E. Gilsanz Murray Steficek LLP, New York, US
Pons i Grau, V. Oficina Tecnica de Ingenieria Forense, Valencia, Spain

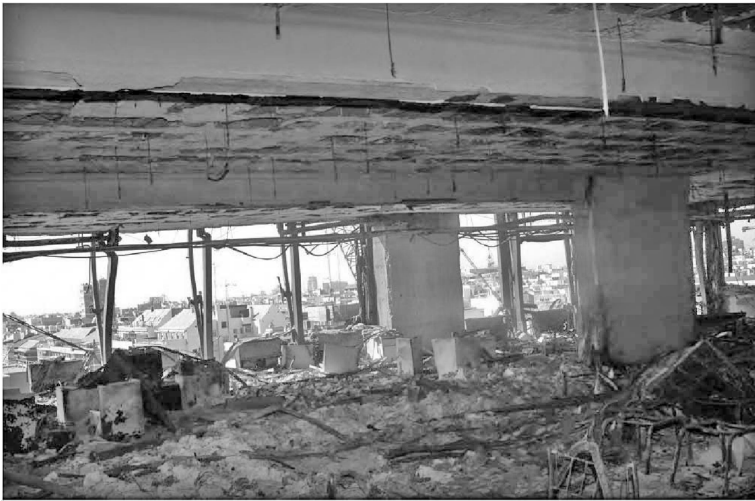
Illustration 6: Building Condition at Lower Floors

Following the event a field inspection was performed. Access to the building was limited due to the extent of the collapse. Illustration 6 shows the condition of the building on the levels below Mechanical Floor #2. The interior partitions had been completely burned, the ceramic fillers showed the thermal effects of the fire and had fallen onto the floor, and the perimeter columns had begun to show the effects of thermal buckling.

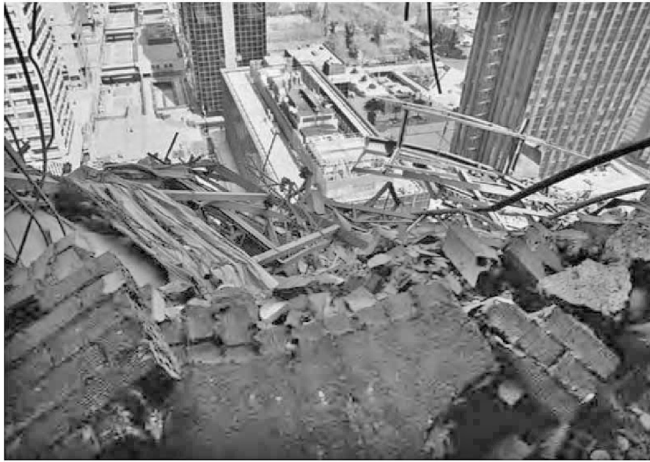
Illustration 7: Building Condition at Upper Floors

Above Mechanical Floor #2, the building was extremely unsafe. Floor slabs were partially or totally collapsed and only the area surrounding the building core was accessible. Illustration 7 is of the floors above Mechanical Floor #2 as seen from the building core.

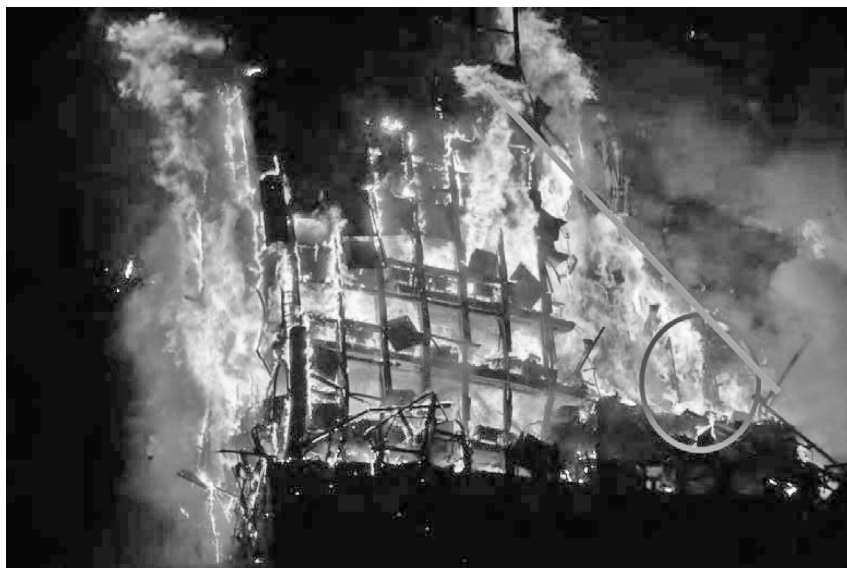
Illustration 8: Fire Evolution

Illustration 8 shows a higher level of destruction at the right side of the east façade, where the fire presumably started.

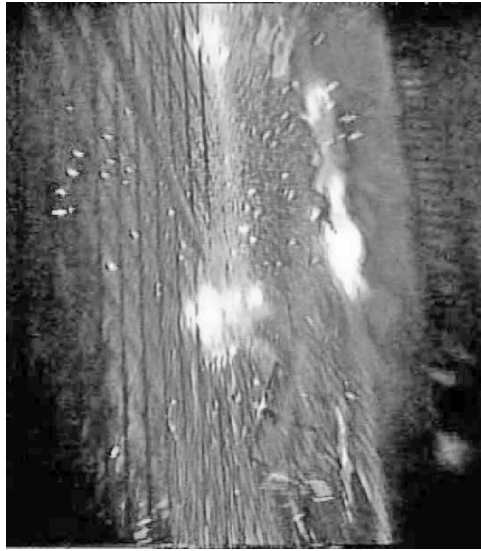
Illustration 9: Fire Explosion

Illustration 9 shows the fire exploding on the 21st floor due to the high fire load.

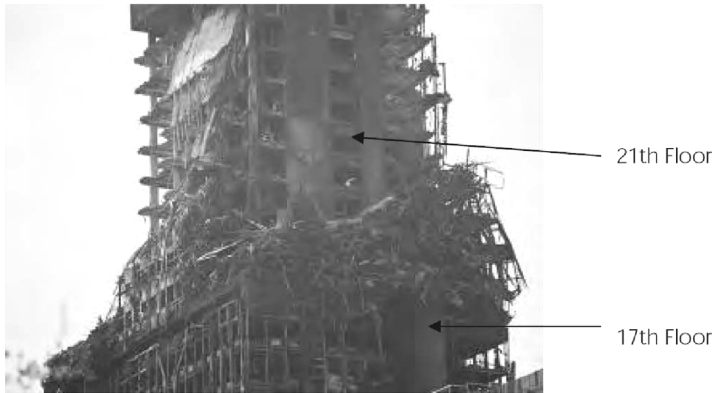
Illustration 10: Collapse Extension

Illustration 10 shows the extent of collapse on the upper floors. The collapse extended to the interior concrete wall on the side of the building where the fire presumably started, and to the first span of frames on the opposite side.

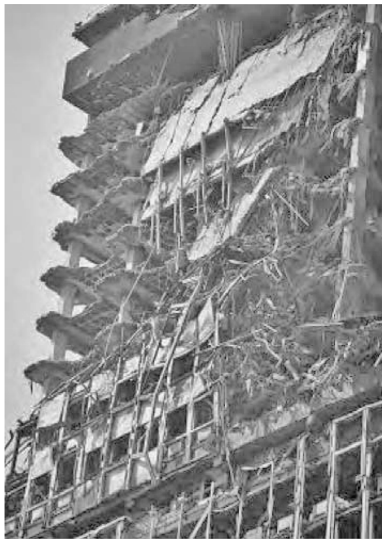
Illustration 11: Building Collapse

Illustration 11 shows the slab system folded one over the other due to the perimeter steel column failure on the 21st floor.

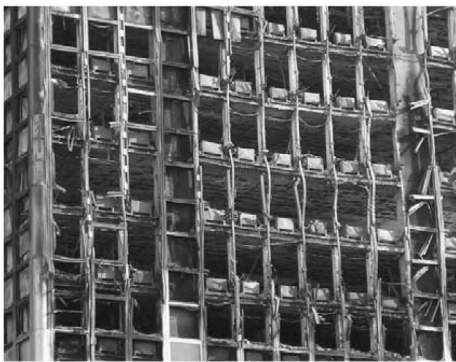
Illustration 12: Lower Levels Damage

The lower levels had a further advantage over progressive collapse due to the fire protection of the perimeter columns and the concrete columns which existed on the short sides of the building facade. However, Illustration 12 shows steel columns on the lower levels with early stages of thermal buckling.
