# CTBUH Journal

Tall buildings: design, construction, and operation | 2015 Issue IV

# Reinventing Woolworth: Adaptive Reuse of a Historic Skyscraper

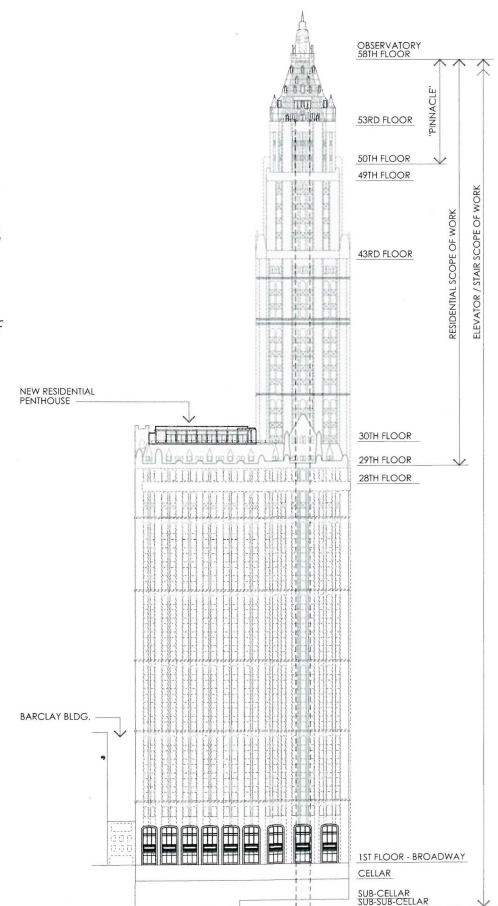
Figure 2. Scope of reconstruction work. © SLCE Architects

The fundamental objective of the project is to renovate and convert the upper 30-story “tower” portion to luxury condominium apartments, without disrupting ongoing office use of the lower 28 floors, which will continue to be occupied throughout the reconstruction (see Figure 2). The structure and proportions of the historic building lend themselves to an attractive, traditional apartment layout, yet a number of upgrades to building infrastructure and services, as well as the addition of new amenities are required. An abandoned basement swimming pool will be restored, in addition to the creation of a new wine cellar.

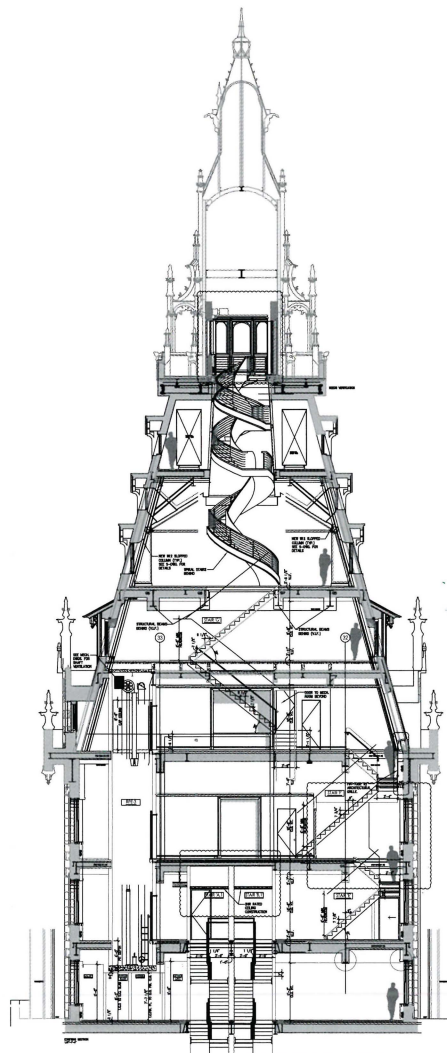
Figure 3. Section at pinnacle residence. © SLCE Architects

The six-story pinnacle will be converted to a single unique residence (see Figure 3). This involves removing a significant amount of floor area, adding an internal private dual-roped hydraulic elevator for that residence, replacing an existing spiral stair used to access the lantern with one that is code-compliant, and adding and enlarging windows and skylights within the landmarked pinnacle roof. Since a substantial portion of the floor diaphragm is

being removed, the frame must be strengthened to support lateral loads at the top of the building.

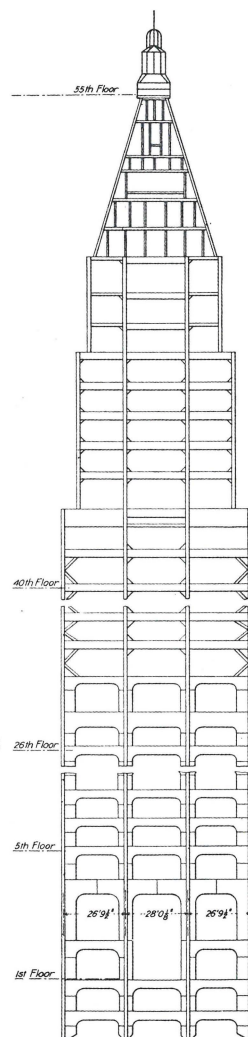
Figure 4. Overview of tower framing (1913). © Gunvald Aus

Wind loads drove the steel frame design, which integrates diverse types of bracing: portal arch bracing, full-story diagonal bracing, and knee bracing (see Figures 4 and 5) (Holtzman 1913). The central tower functions structurally as a highly rigid vertical cantilever and stabilizes the entire building. Where the tower meets the building's flanking wings at the lower 28 floors, portal arches span each structural bay at every story in the tower's front and back elevations. The remainder of the building base is reinforced by concentric chevron bracing and K-shaped knee braces. Between the 28th and 42nd floors, the tower frame is reinforced by diagonal knee braces. Up to the 47th floor,

additional perimeter columns connect to wall girders, and at the 47th to 50th floors, four interior columns join floor girders to resist lateral forces. At floors 50 and above (the pinnacle), inclined members of the pyramidal roof counteract the lateral forces of the wind (Wind Bracing 1912).

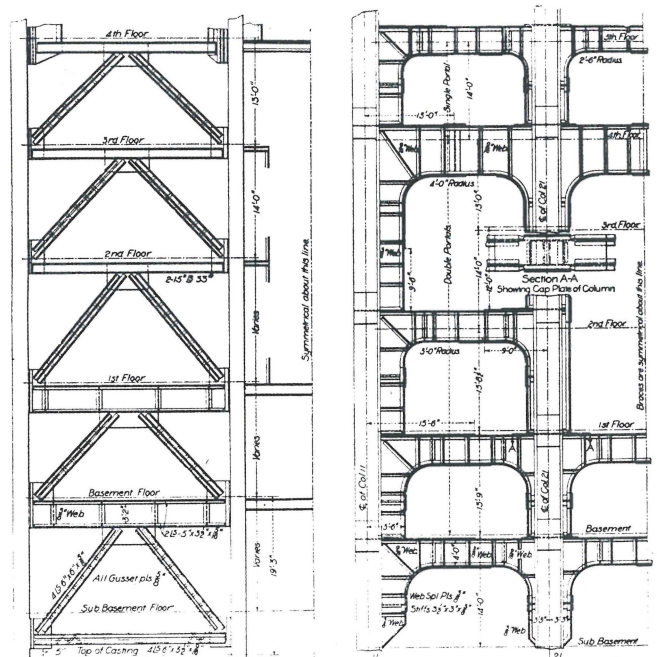
Figure 5. Detail of as-built bracing systems (1913). © Gunvald Aus

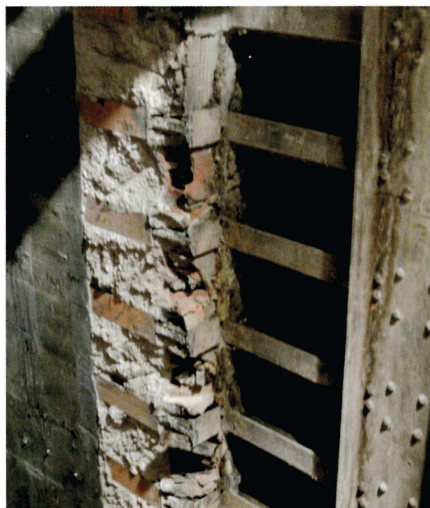
Figure 6. Existing shaft reinforcement.

elevators, a hundred years ago. Novel for its time, this mechanism consisted of large air-tight silo-like chambers at the bottom of the elevator shafts, within which the air beneath a falling elevator cab gets compressed, thus cushioning the drop (Six Hundred-Foot Drop 1913). These "silos" had to be removed, to make space for the new elevator shafts. This demolition was difficult, because they are made of a cage of horizontal web I-beams spaced at 381 millimeters, which is densely packed with terracotta or concrete (see Figure 6).

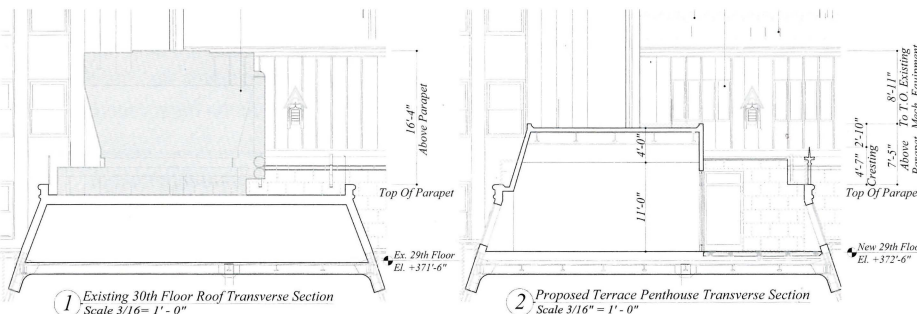
Figure 7. Residential conversion at 29th floor. © Thierry W. Despont

The wings of the 29th floor presented many structural challenges. The basic architectural goal was to take a mechanical space with 1.8 meters of head room and turn it into exclusive penthouse residences (see Figure 7). In order to do this, the architect had to convince Landmarks that the new, higher penthouse could not be seen from the street. The resulting architecture has the higher occupied space set back from the existing mansard roof to leave the sight line from the street unchanged. This meant the existing roof had to be removed, while leaving the mansard in place to hide the new structure. Additionally, the new structure had to be supported without reinforcing anything from below and minimizing the rise in the floor elevation. Complicating this further was the addition of cooling towers and an emergency generator at the far end on one of the wings, coupled with the need to maintain access to an existing elevator machine room and egress stair, also at the far end of the wings.

The fact that the lower half of the building was to remain in active use by office tenants over the duration of reconstruction limited the options for structural reinforcement and required careful coordination of the construction process. Any reinforcement of the slab at the 29th floor – the lowest residential level – had to be applied at top of steel only using WTs (structural tees cut from wide-flange shapes), because the bottom of the steel is not accessible, as that floor remains in use.

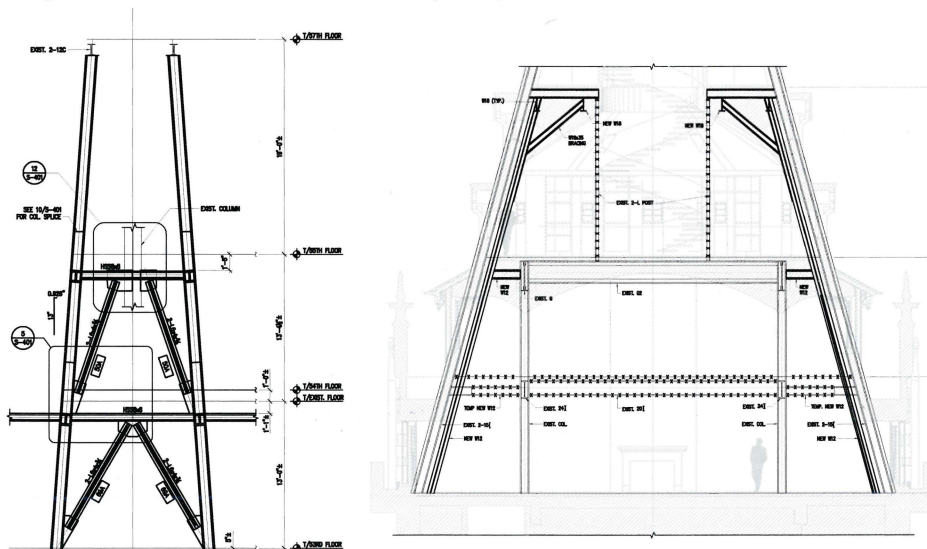
Figure 8. Pinnacle reinforcement.

At the pinnacle, existing posts are removed between the 55th and 57th floors to accommodate the installation of a new spiral staircase to the observation deck. The weight of a new doughnut-shaped, 56,781-liter, two-compartment stainless steel fire storage tank at the 57th floor must therefore be redistributed elsewhere. The supporting frame uses W8 braces to engage new sloped W12 corner columns that parallel the existing sloped exterior frame (see Figure 8).

Since more than half of the slab and floor framing at the 54th floor is removed to create a 7.9-meter-high open space known as the "Great Room," this level loses its diaphragm. Combined with the need to remove significant portions of the terracotta substructure of the sloped roof to increase the window openings, new chevron wind bracing is required at the new corner

columns to maintain stiffness and lateral capacity. New HSS8 frames are installed around the perimeter at floors 54 and 55 to engage existing structure with the new bracing system.
