330 Madison Avenue

Over-cladding the façade of a 1960s high rise with a modern curtain wall system improves performance, appearance, and property value.

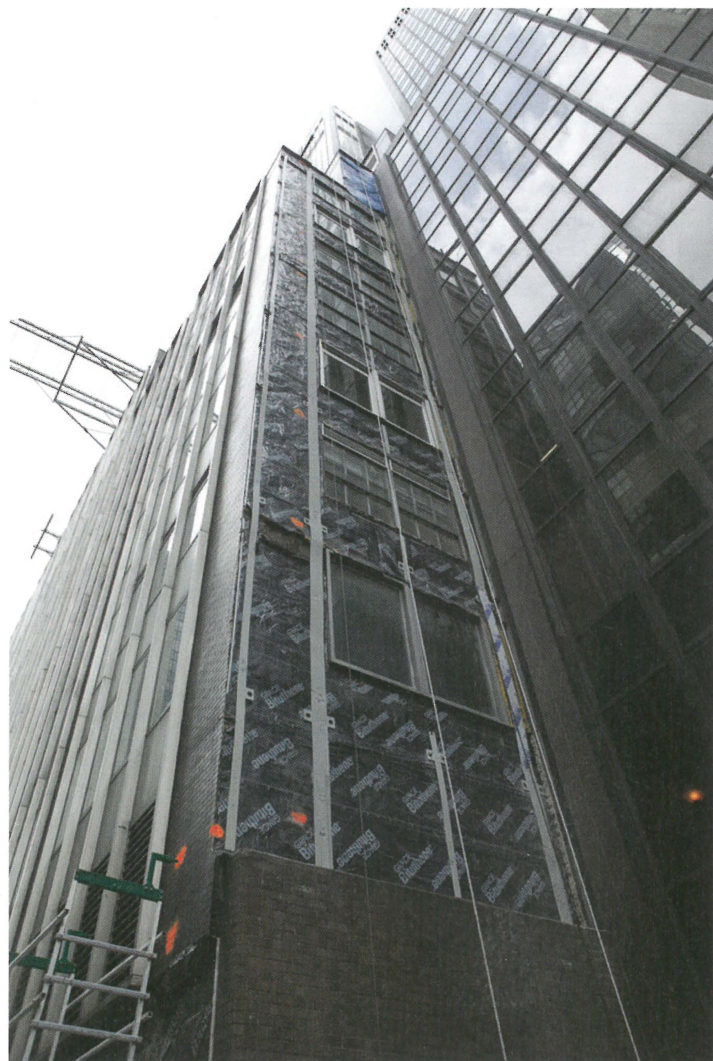
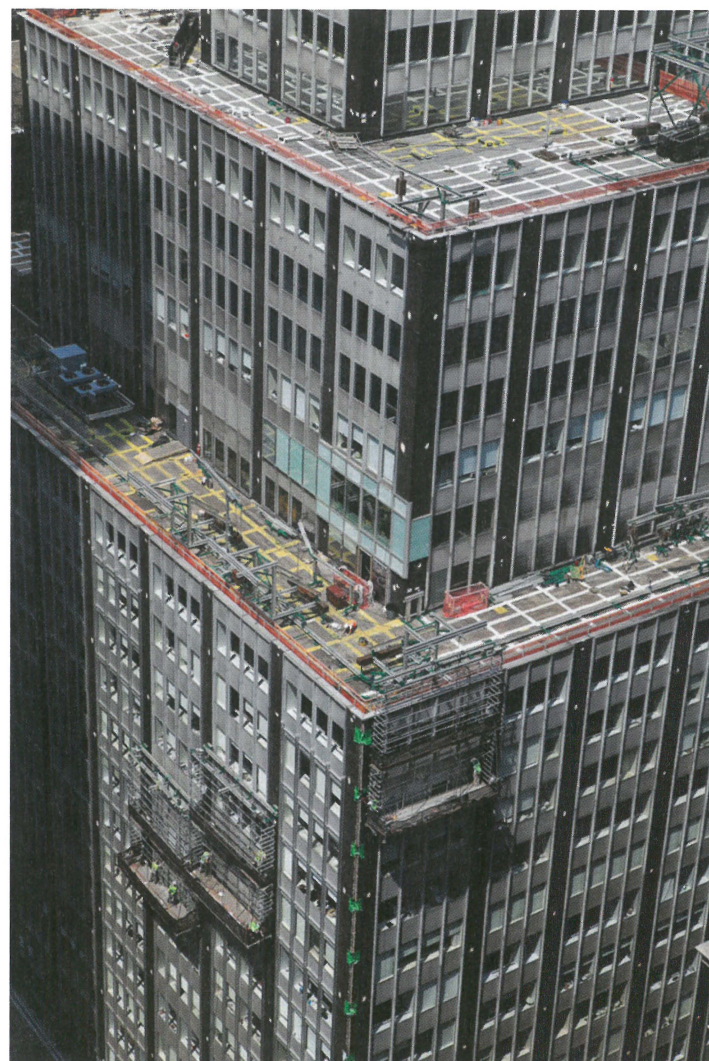
Above A detail of curtain wall replacement underway (left) and a view of the building just as the first new glazing units are installed (right).

analyses, the architects and engineers began to look at options. They settled on a very effective solution that allowed a new curtain wall system to be attached directly to the existing mullions as an "over-cladding" of the building. This design approach offered numerous advantages. First, it reduced the total labor and materials needed, contributing to cost control for the project. Second, it minimized or in some cases eliminated penetrations into the existing skin of the building. Third, it allowed for the new curtain wall system to be installed cleanly from the outside with demolition of the existing windows done after the fact from the inside. Finally, this approach minimized disruption to the tenants who would be occupying the building during construction. That

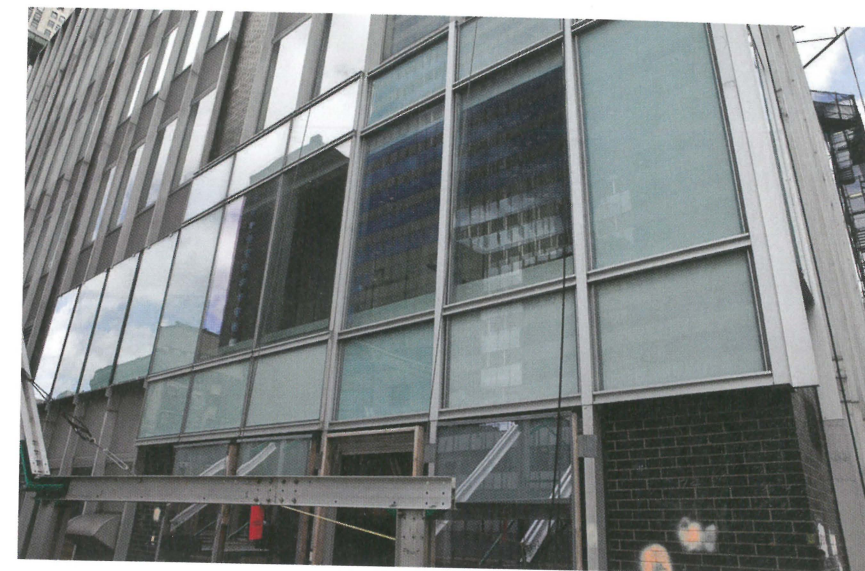
Below The new curtain wall system is installed before existing windows were removed from inside the building.

With the design worked out, the re-positioning team at Tishman Construction was engaged to carry out the \$100 million project. Over the course of two years (2010 to 2012) they used their experience from other such projects to manage significant construction work at the fully occupied site. Several factors were invaluable to the successful execution of the project. First, mock-ups were created of the curtain wall for each building section. Since the lower portion was built to the property line, the curtain wall assembly for this area needed to fit between the existing mullions in order to comply with New York City zoning requirements. The upper areas, which were set back, did not have this restriction, so the curtain wall could be mounted to the face of the existing mullions. Mockups of each of these

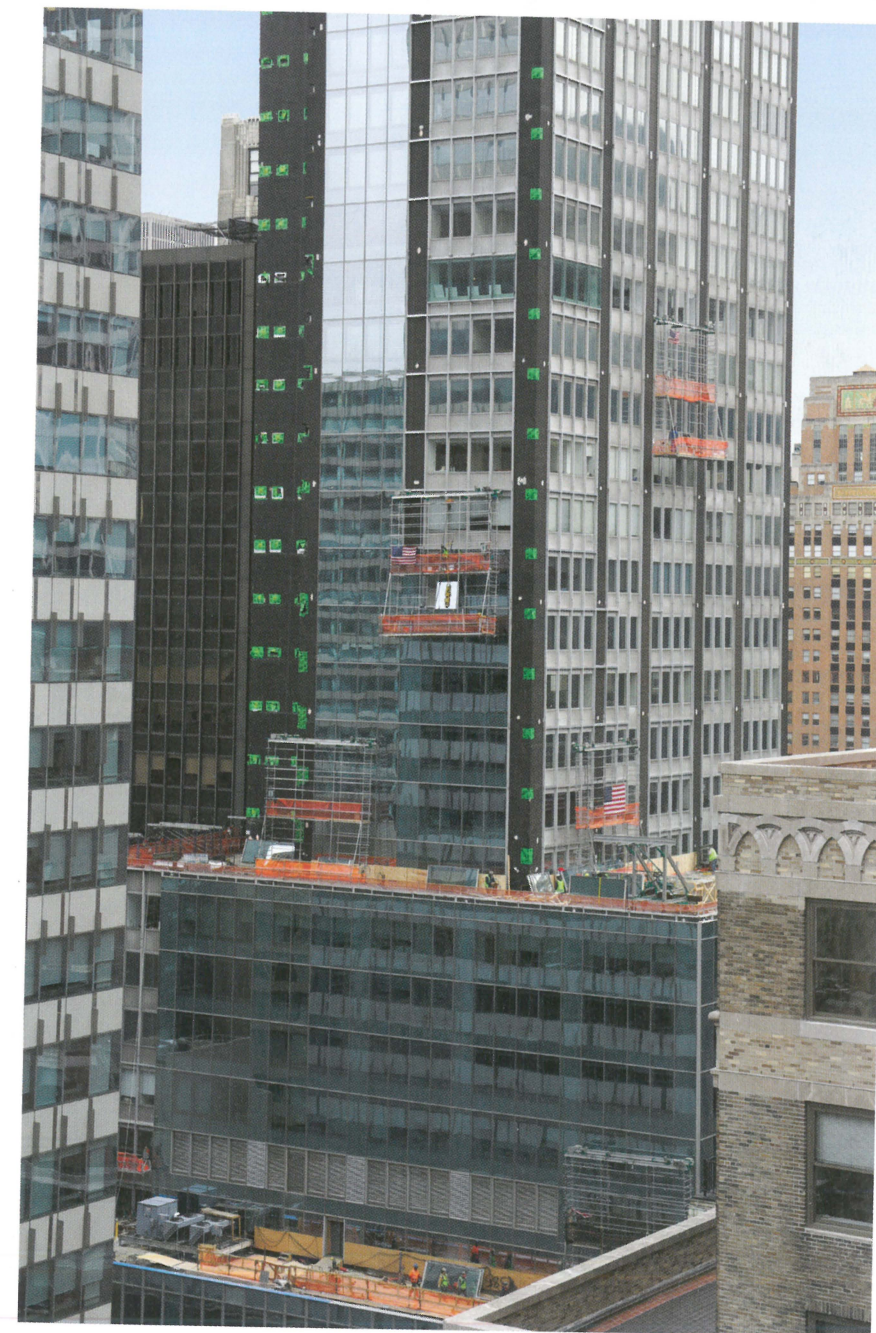
Right Aligned with the original mullion system, the new curtain wall had a 4-foot, 10-inch-by-11 foot, 8-inch glass module.

The glazing of the new curtain wall received considerable attention. Mike Zaborski, project architect with MdeAS, points out that, "Working from the original mullion system, the new curtain wall had a 4-foot, 10-inch-by-11 foot, 8-inch glass module, typically with one glass panel for the full floor height." The specified glazing is 1½-inch-thick double pane, insulated glazing units (IGUs) from Viracon to improve energy efficiency and indoor comfort. The outer lite is ⅜ inches (10 mm) thick clear, heat strengthened glass with a low-e coating (VRE-46) on the #2 surface. The ½-inch (13.2 mm) airspace uses a mill finish spacer and gray
