Lessons from the Sept. 19 Mexico Earthquake

*October 18, 2017**Nadine M. Post*

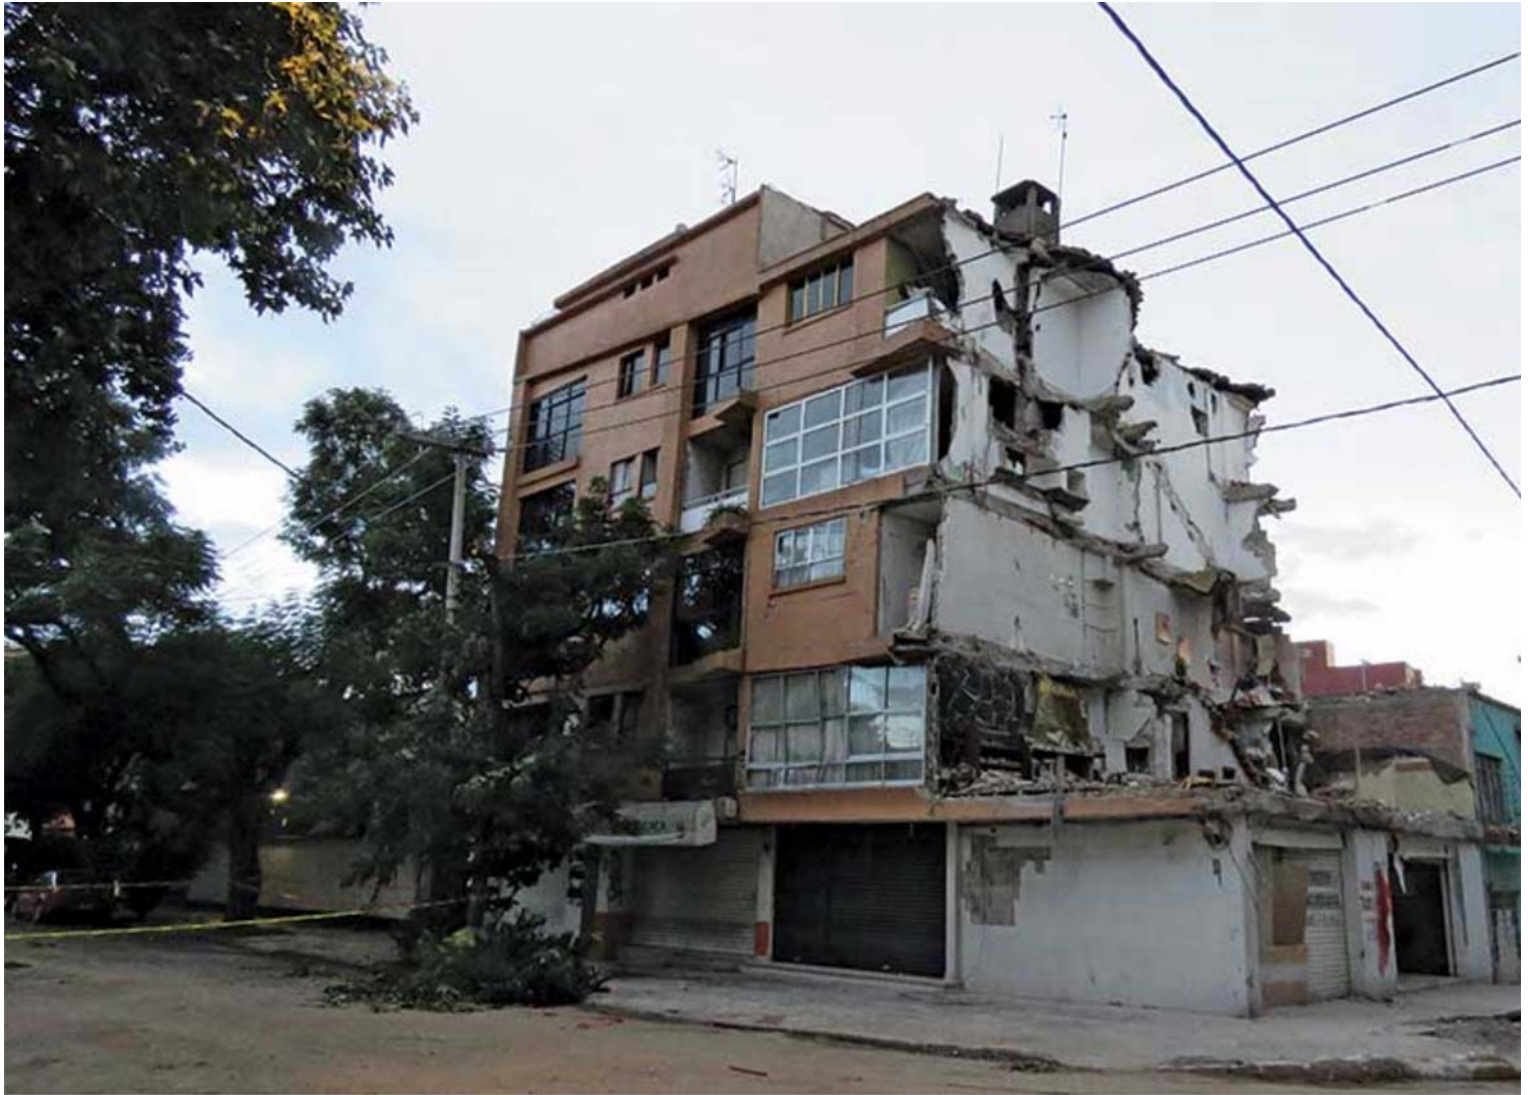
Common Collapse More than 60% of the 44 building collapses in the Sept. 19 quake involved a reinforced-concrete-column-beam system. *Photo by Pablo Heresi*

In the quake, 27 of the buildings that collapsed had reinforced-concrete columns with flat slabs. Nine were unreinforced masonry structures. Four collapses involved structures with confined masonry walls; three had reinforced-concrete frames; and one building had a mixed steel-and-concrete structure, according to a report by a team from Stanford University, which studied the damage in Mexico during a Sept. 19-25 trip.

The most common cause of the failures was insufficient or badly anchored transverse steel reinforcement, called stirrups, says Eduardo Miranda, the Stanford engineering professor who led the Mexico trip.

Stirrups could be too far apart or bent only 90° at the corners, as opposed to 135° inward to the center of the column, as is required in modern seismic codes, explains Miranda. Other commonly observed failures were in the slab-column connections and beam-to-column connections, he adds.
